BIOLOGICAL RESOURCES EVALUATION

Penske Sales, Leasing, and Maintenance Facility Project

Riverside County, California

September 2022

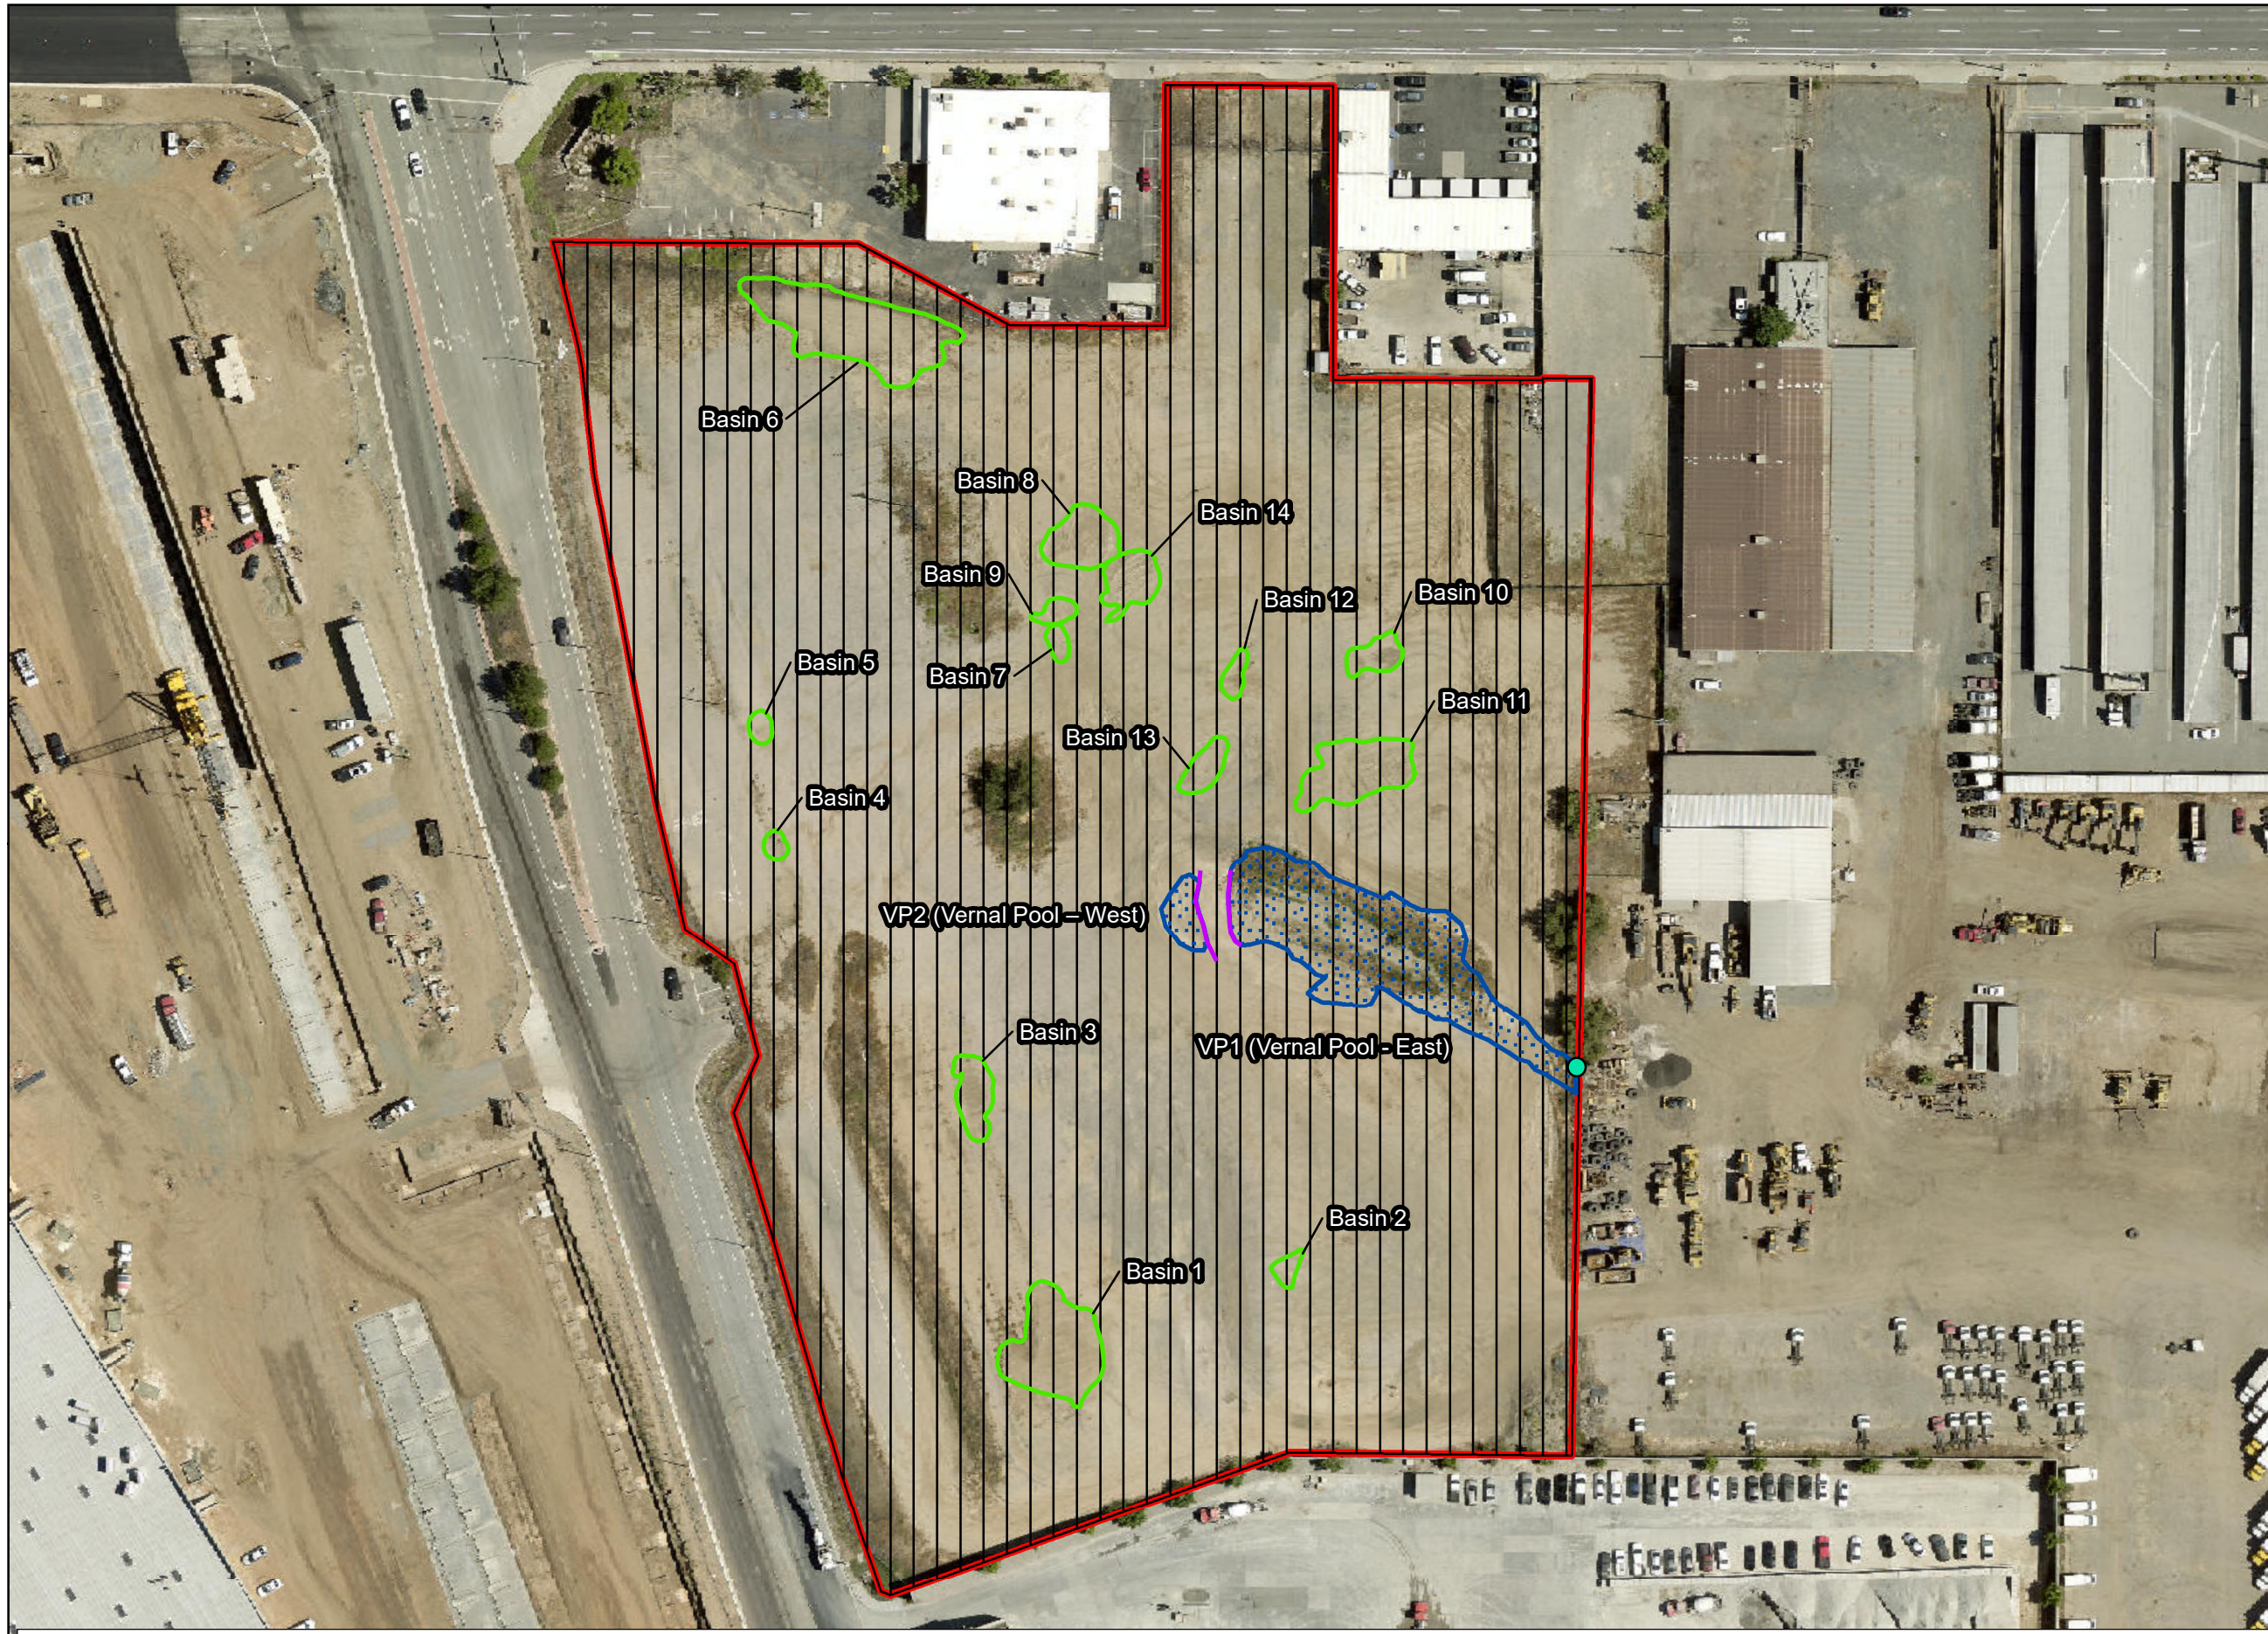
Figure 6

- Project Boundary
- Permanent Impacts
- Jurisdictional Areas**
- Vernal Pool Complex (RWQCB/MSHCP)
- Non-Jurisdictional Basins**
- Basin
- Other Features**
- Culvert
- Dirt Road

Jurisdictional Impact Areas

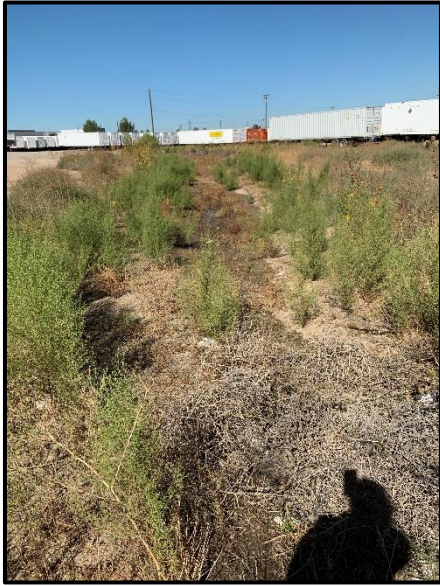
PHOTO 1: VP1 at east boundary near culvert. Water visible in mid-center. View is northwest (October 14, 2021).

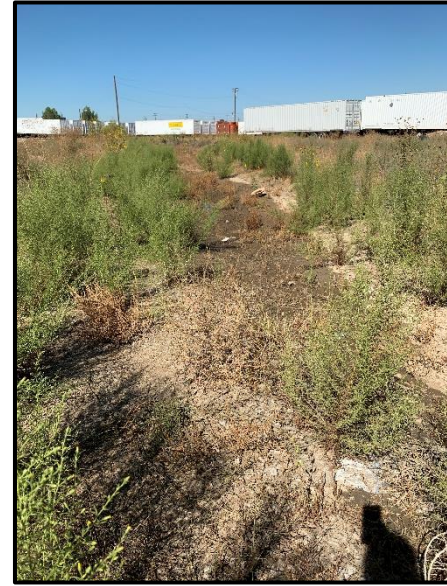
PHOTO 2: VP1 near east boundary. Mud cracks visible in foreground; fairy shrimp pond visible in midground. View is northwest (October 14, 2021).

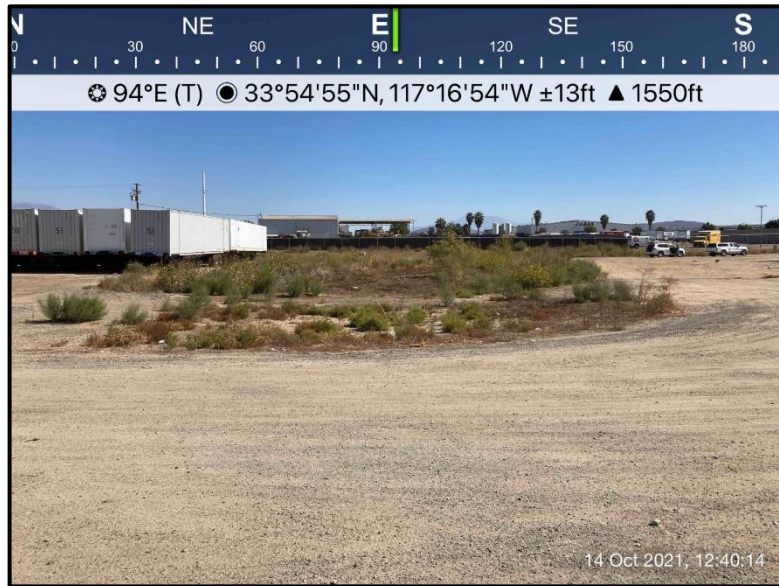
PHOTO 3: VP2 and VP1. View is southeast toward culvert (October 14, 2021).

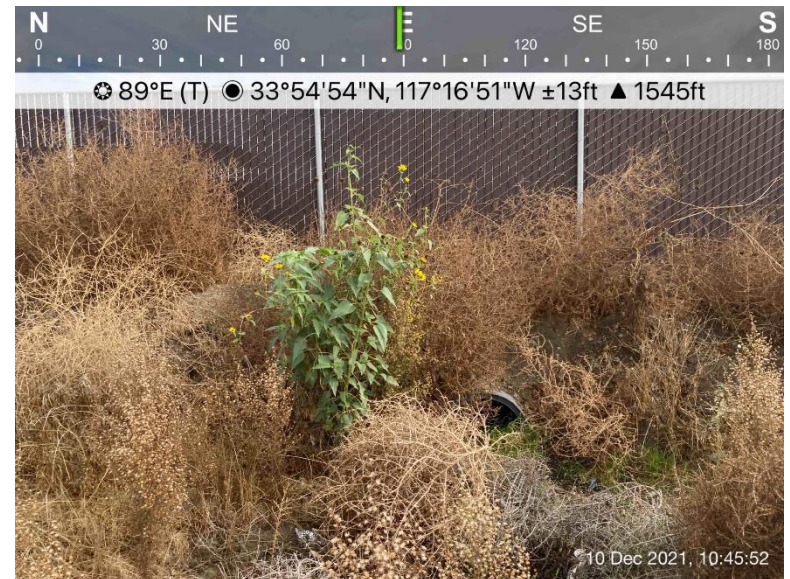
PHOTO 4: Culvert at eastern boundary. View is east (December 10, 2021).

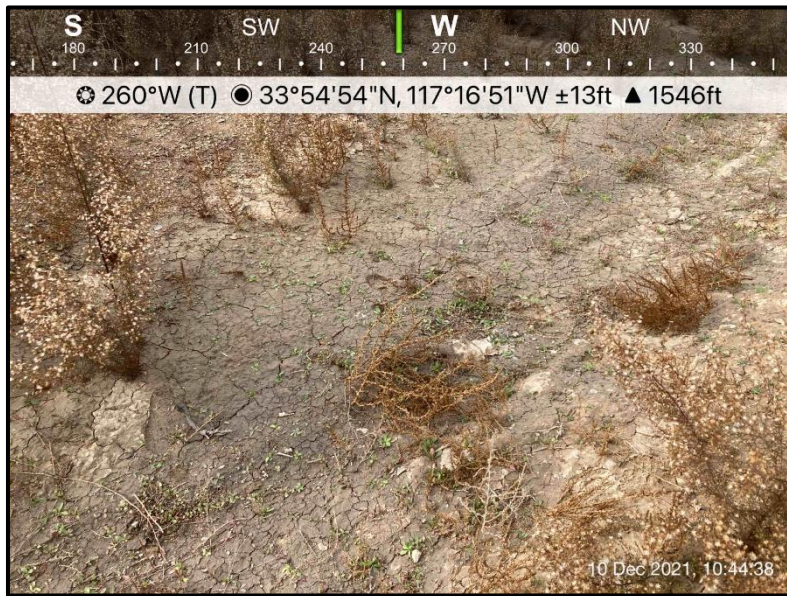
PHOTO 5: VP1 mud cracks near culvert. View is west (December 10, 2021).

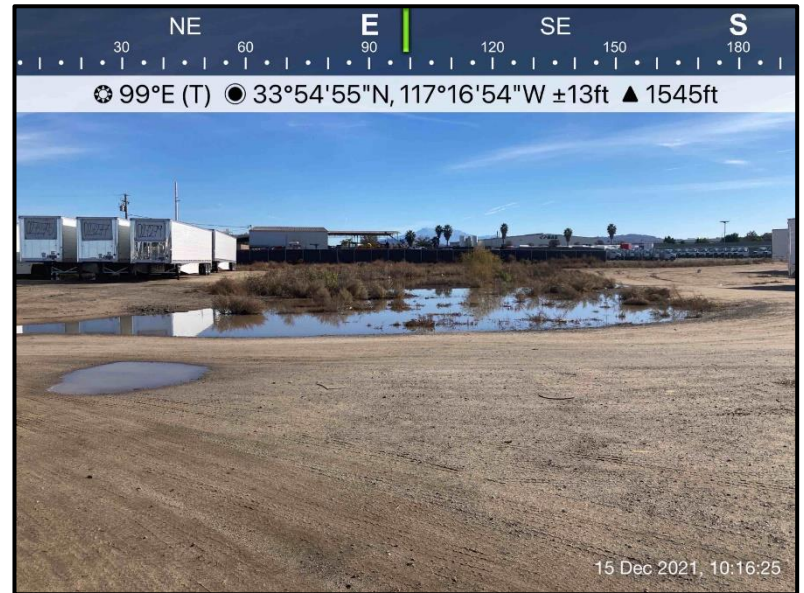
PHOTO 6: VP2 and VP1 merged after large precipitation event. View is southeast (December 15, 2021).

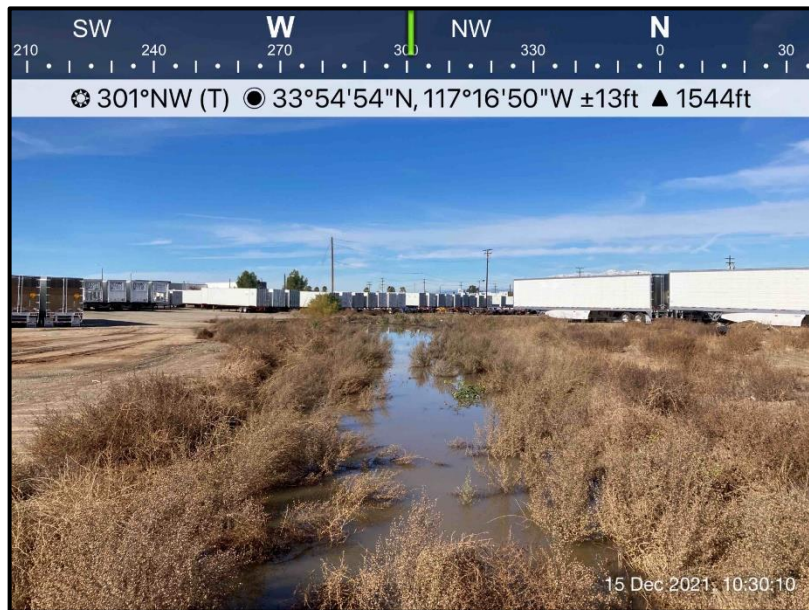
PHOTO 7: VP1 following large precipitation event. View is northwest (December 15, 2021).

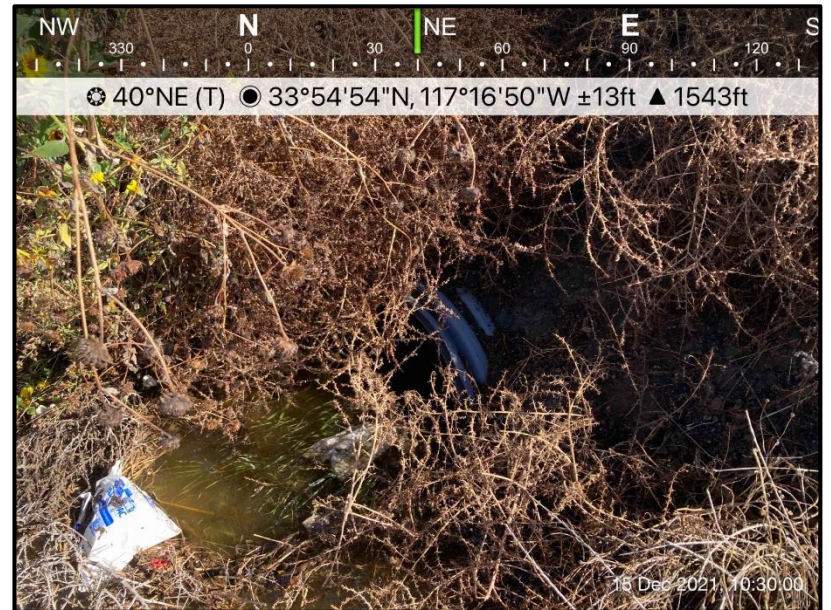
PHOTO 8: Culvert at eastern boundary showing water presence following large precipitation event. View is northeast (December 15, 2021).

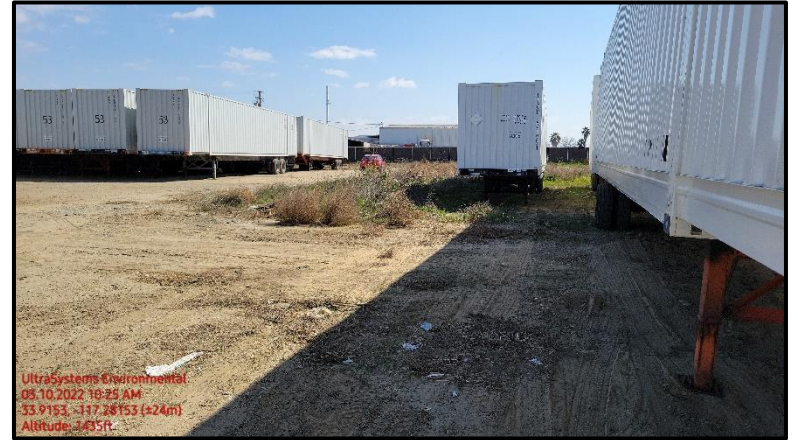
PHOTO 10: VP2, Red car in background is adjacent to VP1. Note encroachment of white trailer to VP2 and VP1. View is east (March 10, 2022).

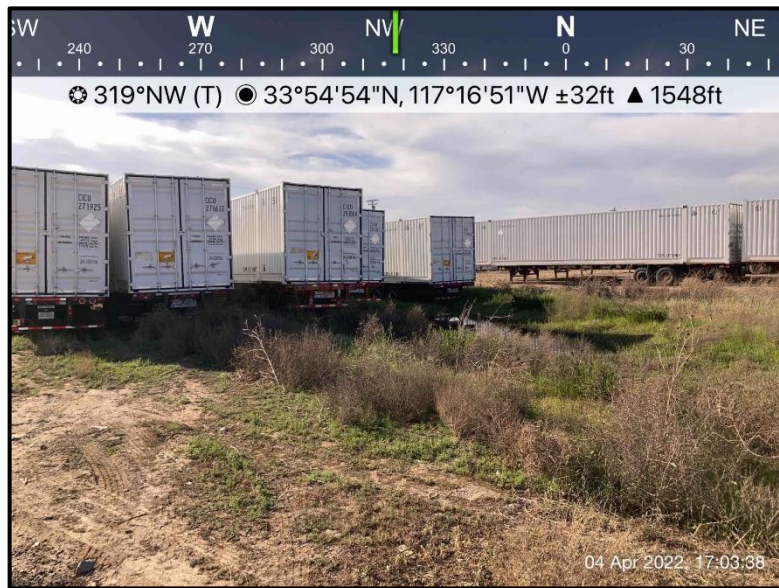
PHOTO 11: VP1, south of culvert. Notice encroachment of trailers on VP2 and VP1. Water is visible in VP1 beneath the last trailer. View is northwest (April 8, 2022).

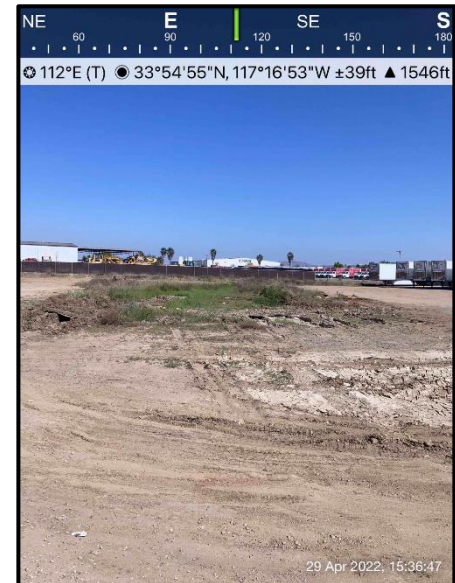
PHOTO 12: VP2 and VP1. Note mud cracks in VP2, right foreground. View is southeast (May 2, 2022).

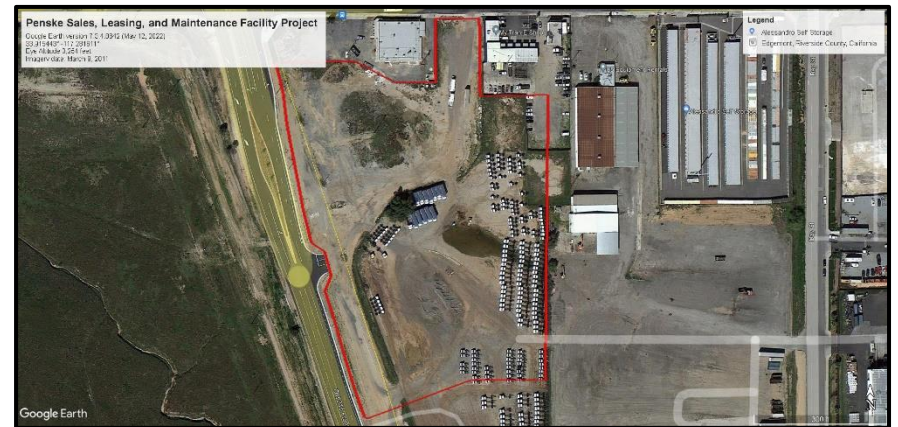
PHOTO 14: Surface water visible in aerial imagery, March 9, 2011 (Google Earth 2022a).

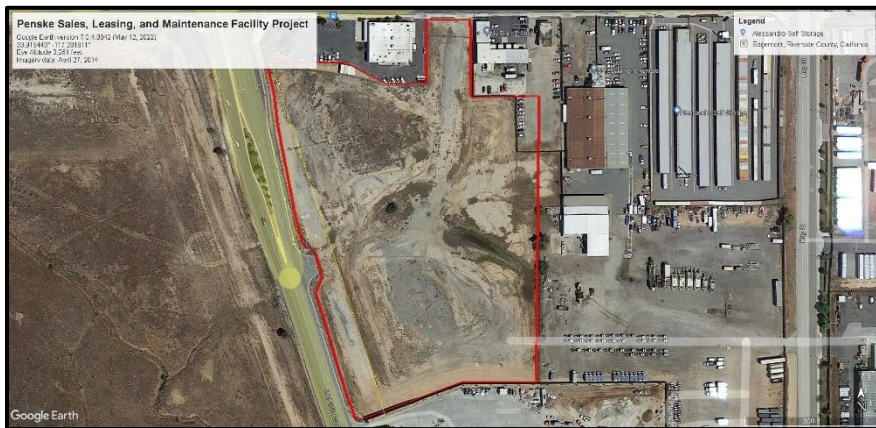
PHOTO 15: Surface water visible in aerial imagery, April 27, 2014 (Google Earth 2022a).

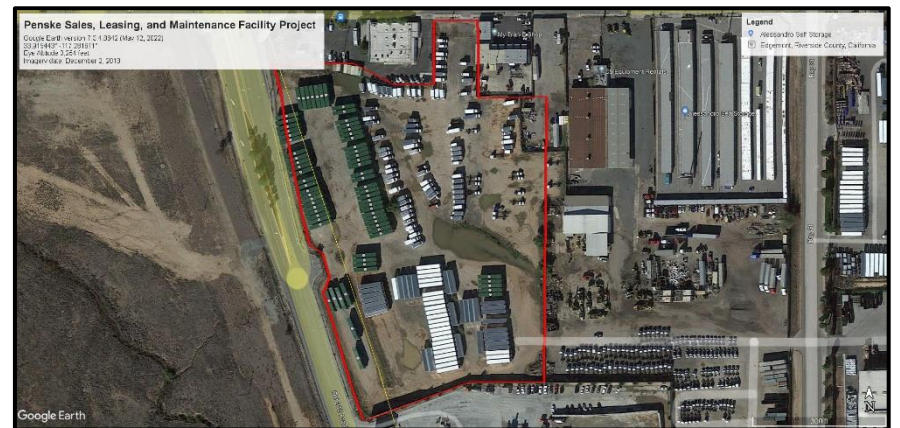
PHOTO 16: Surface water visible in aerial imagery, December 2, 2018 (Google Earth 2022a).

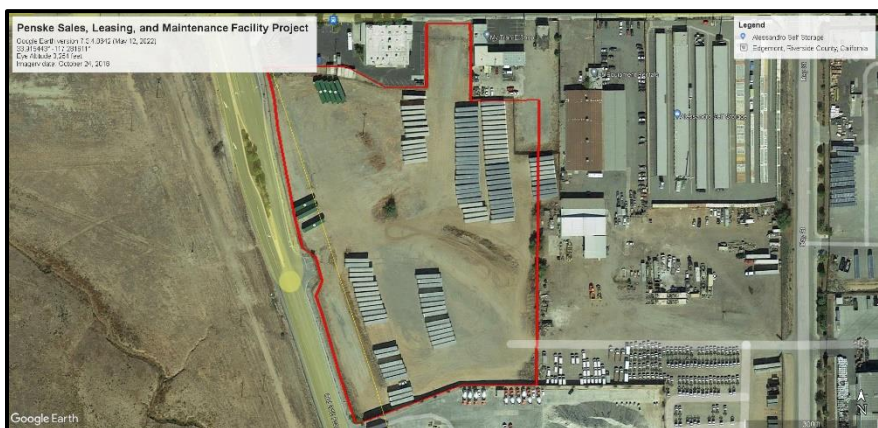
PHOTO 17: Attempt has been made to fill in vernal pools, October 24, 2016 (Google Earth 2022b).

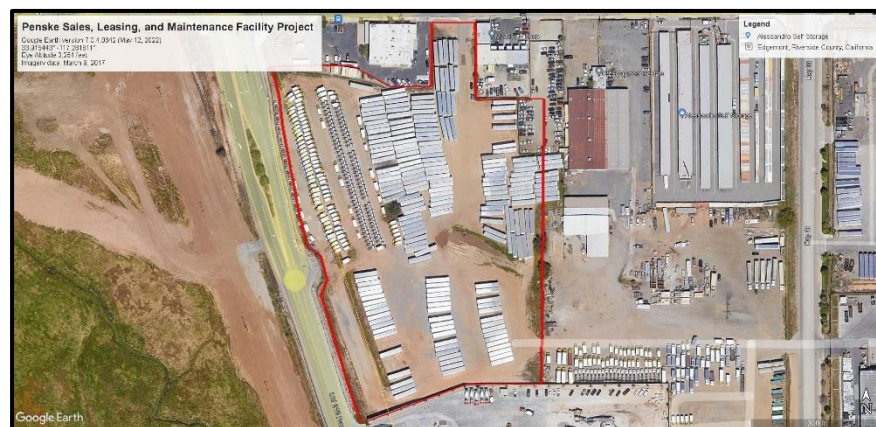
PHOTO 18: VP1 and VP2 re-establishing, March 9, 2017 (Google Earth 2022a).

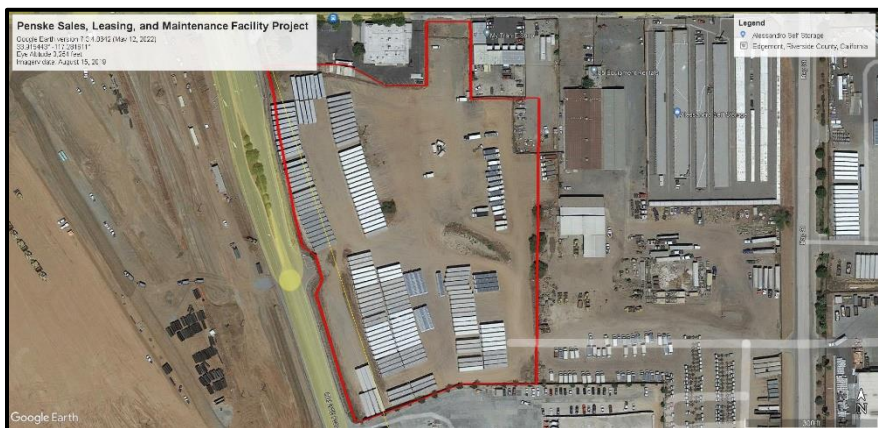
PHOTO 19: Attempt made to fill in vernal pools, August 15, 2019 (Google Earth 2022b).

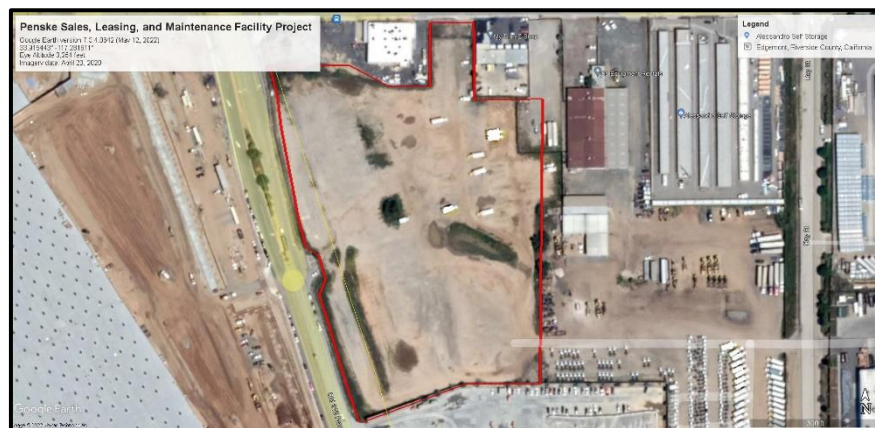
PHOTO 20: VP1 and VP2 re-establishing, April 23, 2020 (Google Earth 2022a).
